Restoration Update July 2023, Bob Burke

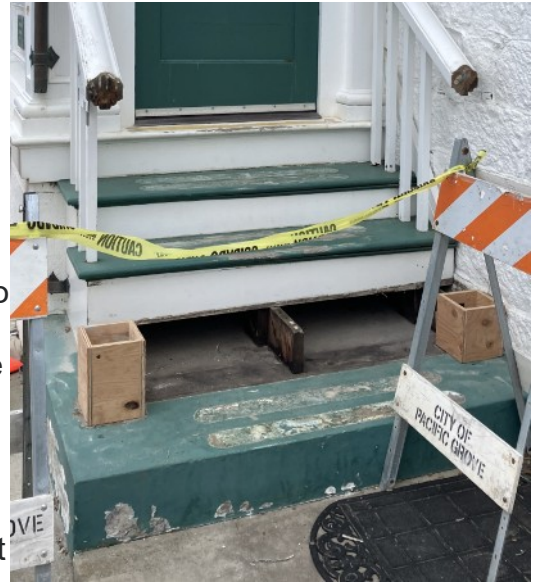
Staircase restoration

The lower stair and bottom portions of both stairway newel posts were found to have significant rotting likely due to water damage. The bottom stair and riser were repaired with penetrating epoxy and epoxy filler. Both newel posts were removed and about 10-inches of the lower portion of each post was cut off to remove any damaged wood. A hole was drilled through the base of the concrete landing at the center of each post footing to accommodate a 1 1/8" galvanized steel pipe, with a corresponding hole drilled up through the post. The pipe was affixed into the hole within the existing concrete with epoxy filler. To compensate for the lost lower portion of each newel post, concrete footings with the same dimension as the post are being cast in place and will secure the steel pipe. The newel posts are to be set down over the pipes to the top of the footing with the joint between the footing and wood post covered with wood down to ground level.

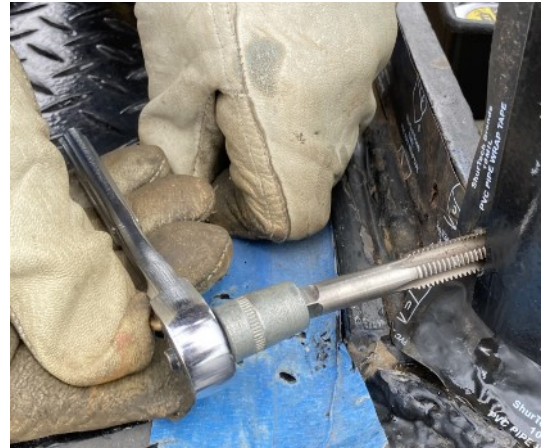
Steel Plate in Lantern Room

Fitting the stainless steel plates to the outside of the lens room at the top of the lighthouse required rethreading of a large number of the existing bolt holes.

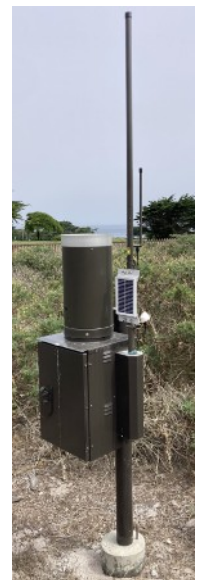
Weather Station?

Installed less than 5 years ago about 50 m NE of the lighthouse, this structure appears to be a weather station. However, we have been unable to discover any government agency who takes responsibility for the structure or can tell us its purpose.
