Lighthouse Log
December 27, 2021

What The Heck is Taking So Long!?

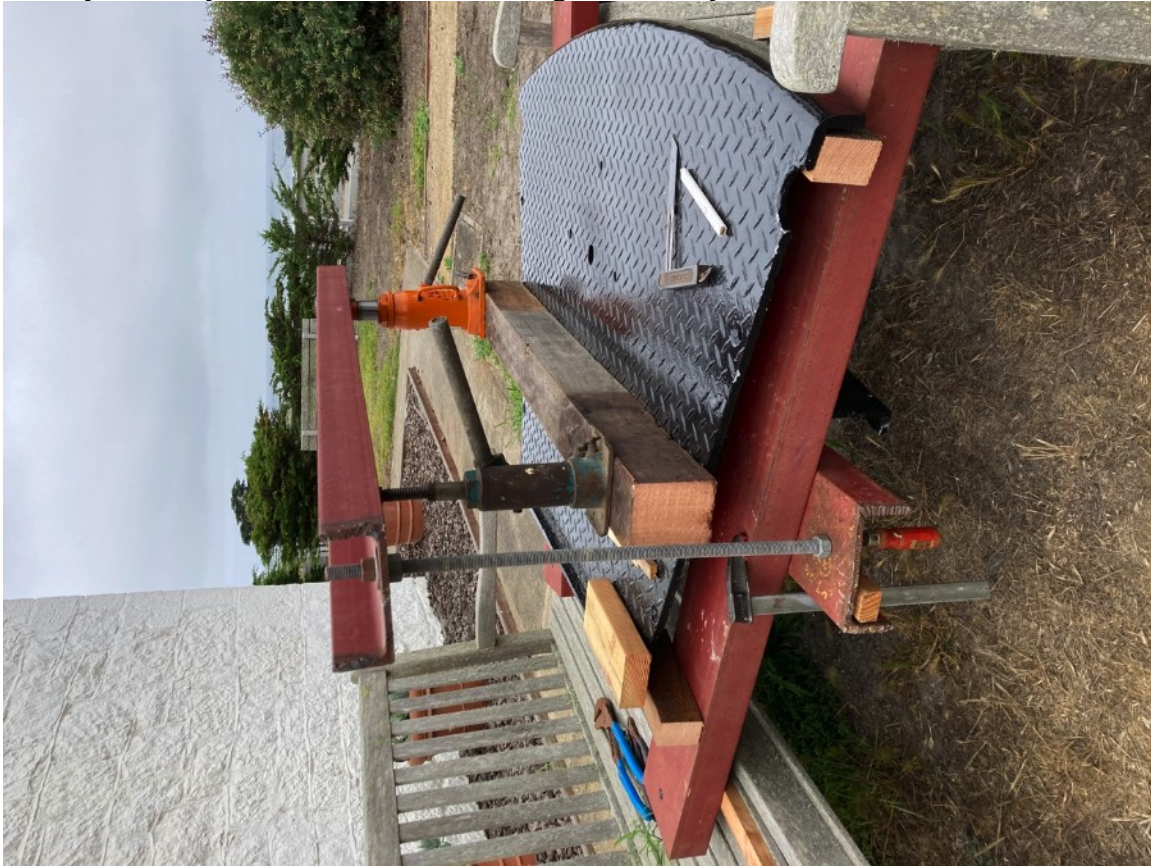
Hydraulic press constructed to straighten deck panels.

Replacement wall plates were made from stainless steel coated with black epoxy paint and are awaiting installation. The ten 65-pound aluminum deck plates were sandblasted, heavily corroded areas were repaired and then they were coated with a very expensive (but donated by Jamie!) two-part epoxy black coating. Unfortunately the sandblasting appears to have caused the panels to bend, so Lowell needed to assemble a special hydraulic press to straighten the panels.
